## Pietermaritzburg Integrated Rapid Transport Network Itemised assessment of the Church Street section

**For direct submission to *Amafa aKwaZulu-Natali***

**Phase IV submission:  
Timber Street to Boschhoff Street  
June 2016**

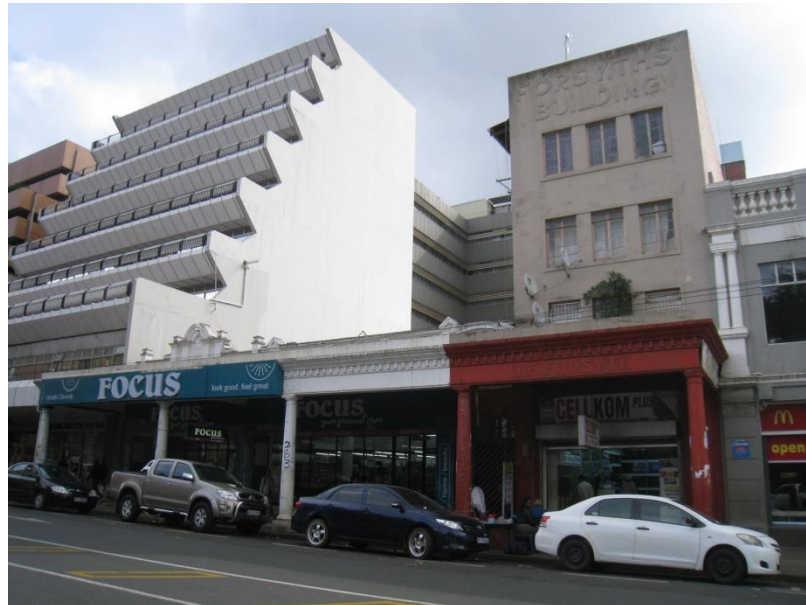
This structure has been extensively altered and has suffered from much abuse in recent years. There is little left by way of a shopfront. Further, the building has not been maintained. These observations inform the recommendations.

**Fig 107: Four storey Forsyth's Buildings from across the street**

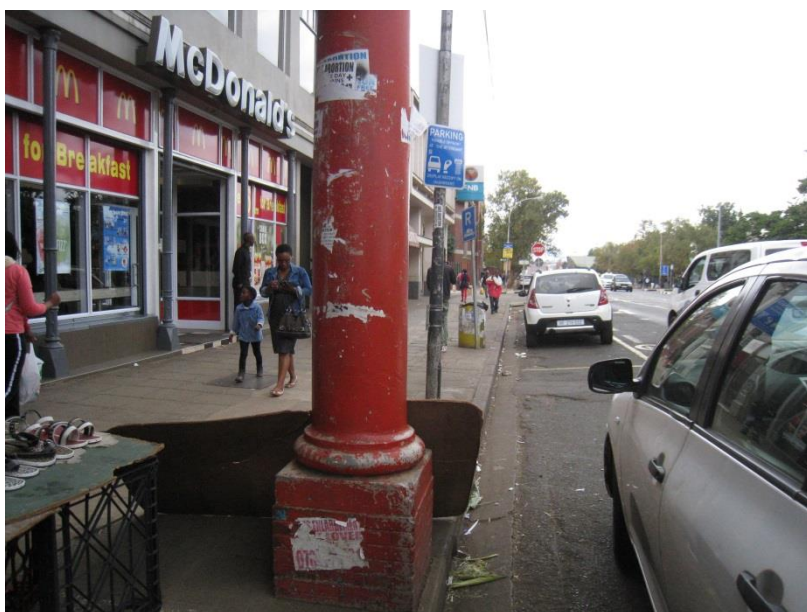
**Fig 110: End of colonnade of 279 – 283 Church Street looking down Church Street at 285 (McDonalds)**

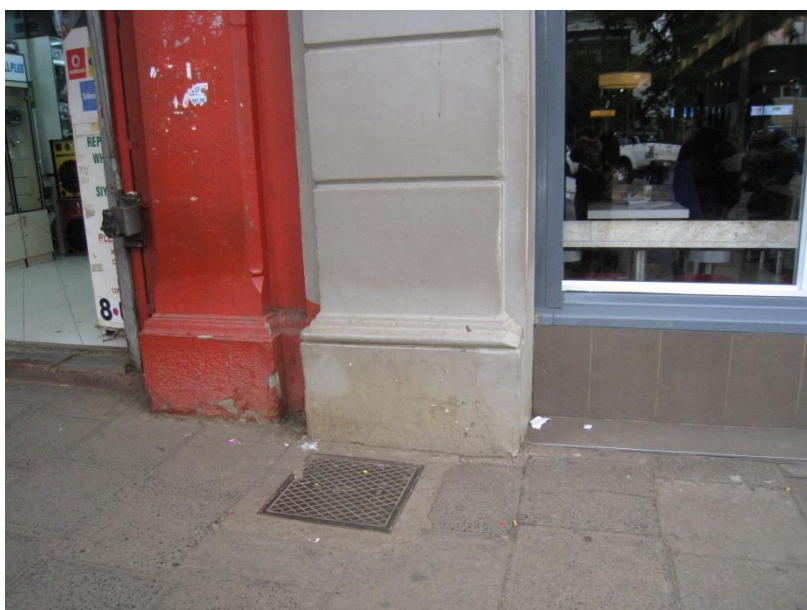
**Fig 112: Junction of 283 Church Street and 285 Church Street**

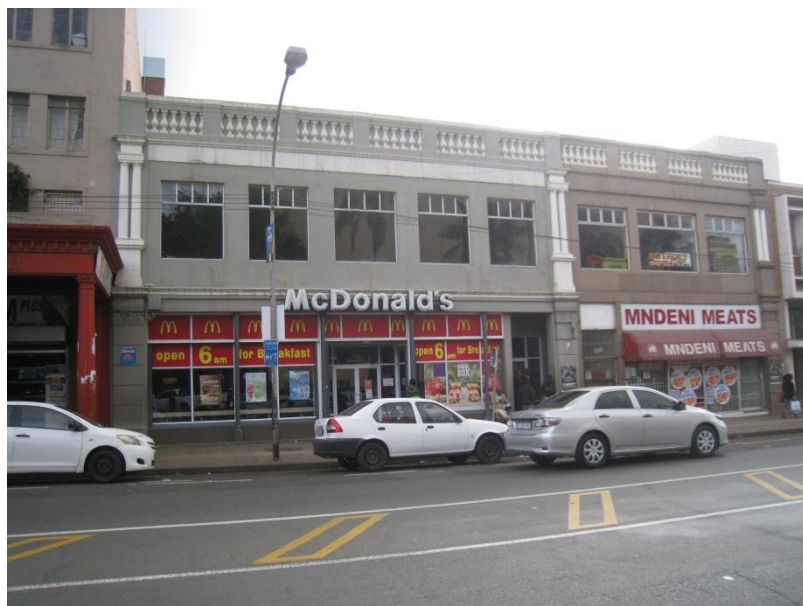
This structure has been extensively altered at ground floor level. There is little left by way of a shopfront, nor is there any evidence at street level as to what the original elevation offered. Further, the building may have been renovated in recent years, but it has not been maintained. These observations inform the recommendations.

**Fig 113: 285 – 287 Church Street from across the street**

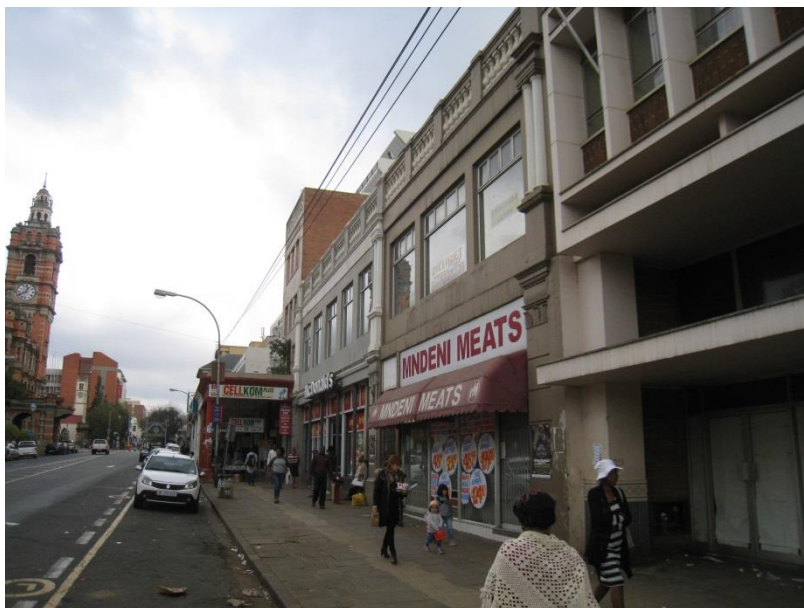
**Fig 114: 287 Church Street in the foreground and 285 Church Street behind**

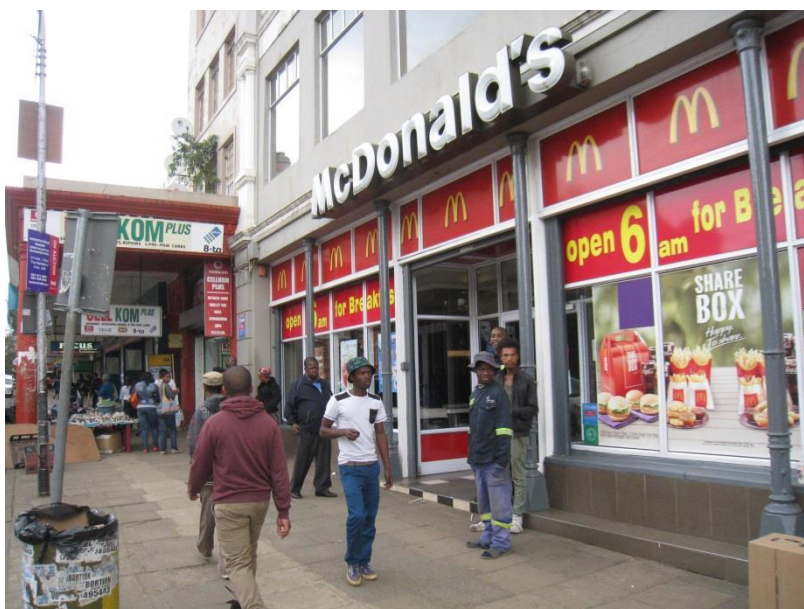
**Fig 115: Shopfront – pavement interface 285 Church Street**

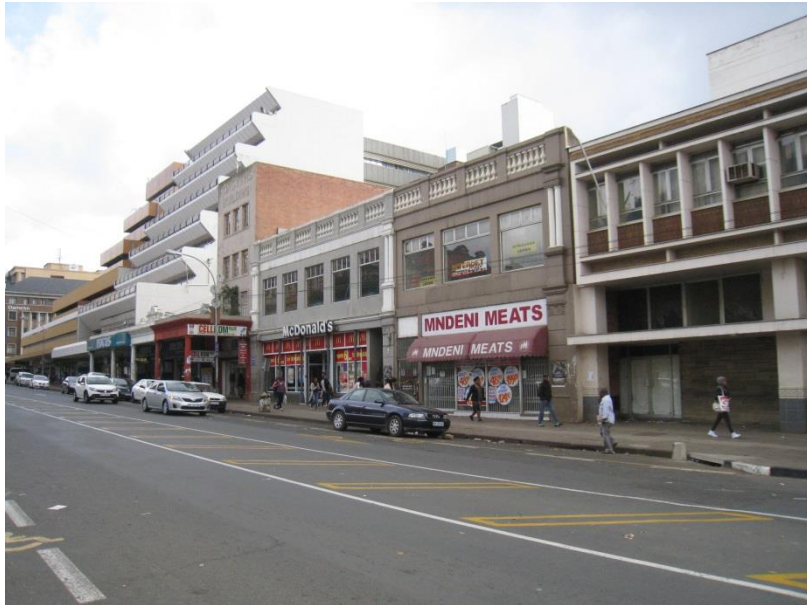
**Fig 116: 285-287 Church Street with relation to 289 Church Street (First National Bank)**

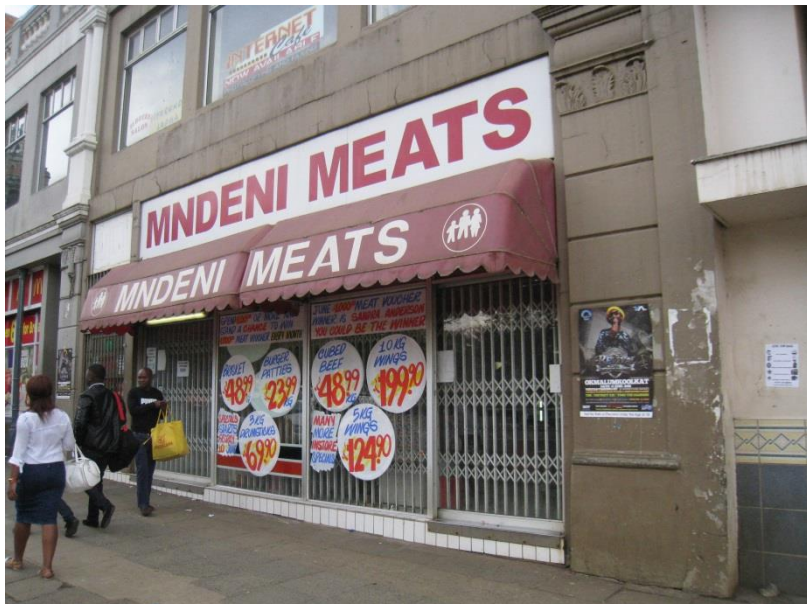
**Fig 117: Shopfront – pavement interface for 287 Church Street**

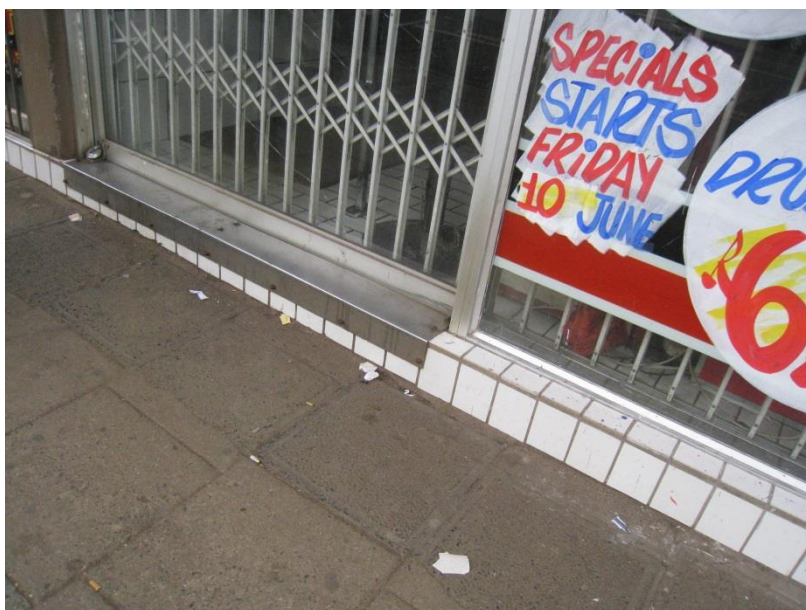
**Fig 118: Detail of shopfront – pavement interface 287 Church Street**

Given the value and condition of this building, recommendations are as such:

- The work on site must be supervised at all times.
- Given that the time between the documentation exercise in this report and the commencement of work on site can result in further damage to the structure, prior to carrying out work, the contractor must take a thorough, detailed set of dated photographs in order to be able to monitor the works in the event of damage.

- The supervisor and the architect for the project are to be directly accountable for any impact to the building.
- Should the building be damaged in any manner as a result of works to the pavement, the damage must be repaired by the contractor, and carried out in accordance with Amafa conditions and requirements.

- When excavation is being carried out, the base of the building and the foundations must be protected from impact
- No pneumatic machinery is to be used in close proximity to the walls of the building.

- At the slightest sight of cracks to the walls that were not in existence prior to work being carried out, all work in proximity to the building and its cracks must cease.

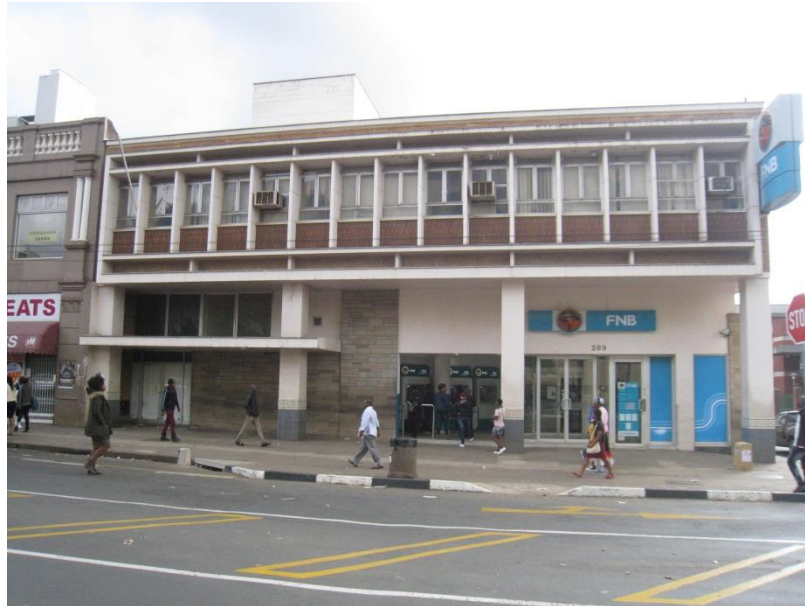
This building is in reasonably good condition. However, the state of cleanliness in the area around its base has much to be desired.

**Fig 119: 289 Church Street from across the street**

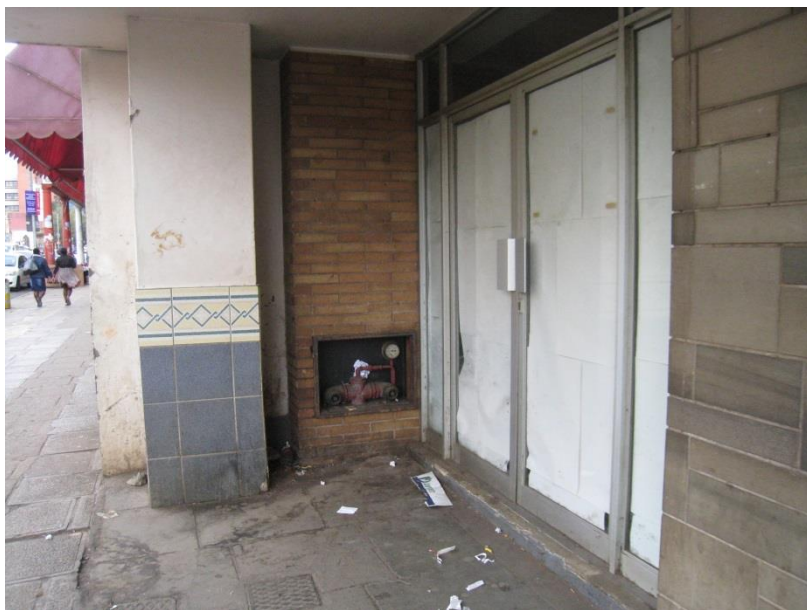
**Fig 120: Showing the junction of 287 Church Street and the recessed façade of 289 Church Street**

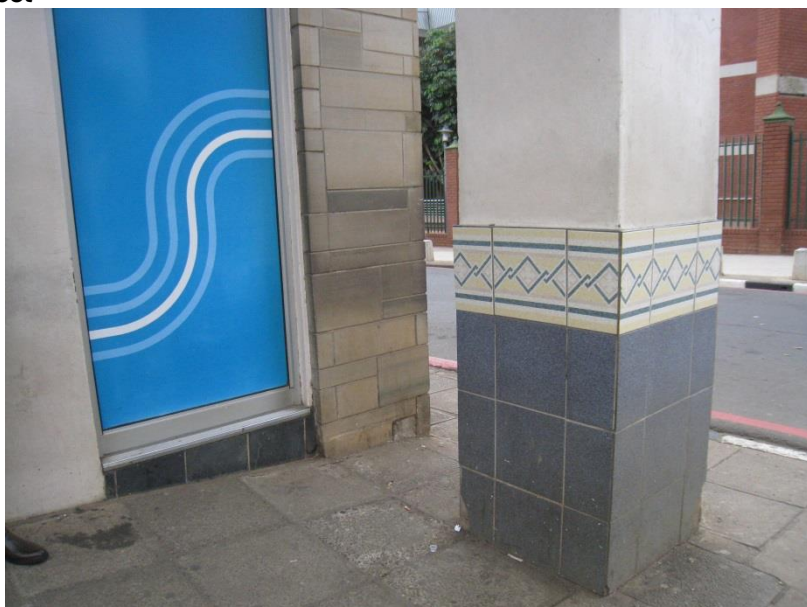
**Fig 121: Corner detail of 289 Church Street**

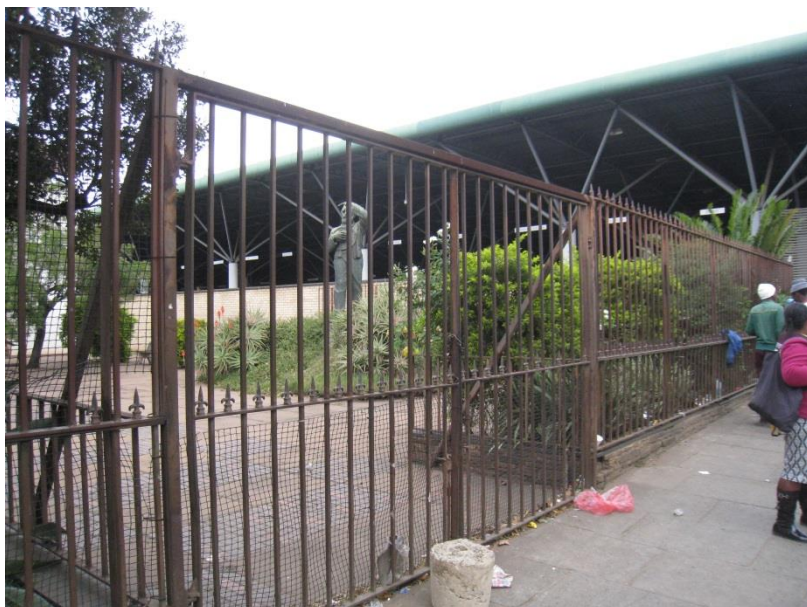
**Fig 123: Showing fence to gardens at NG Kerk**

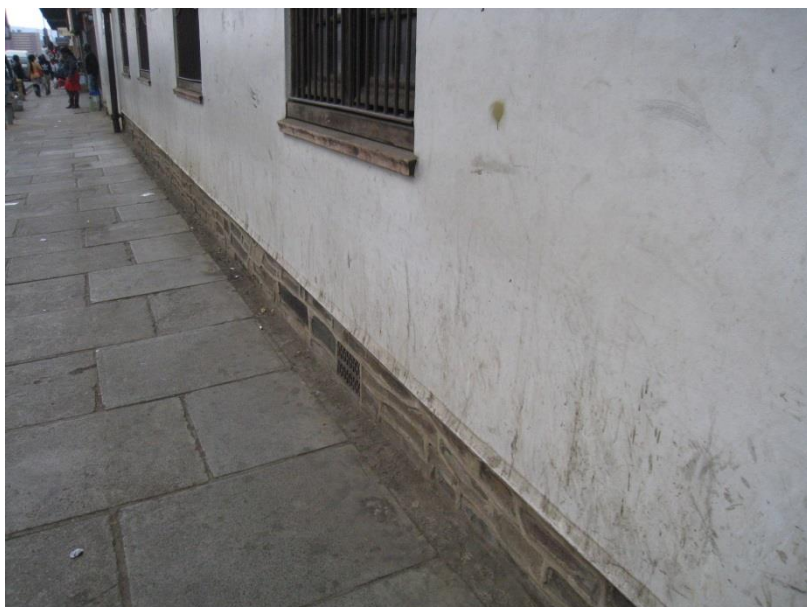
**Fig 127: Church of the Vow wall and shale base – pavement interface**

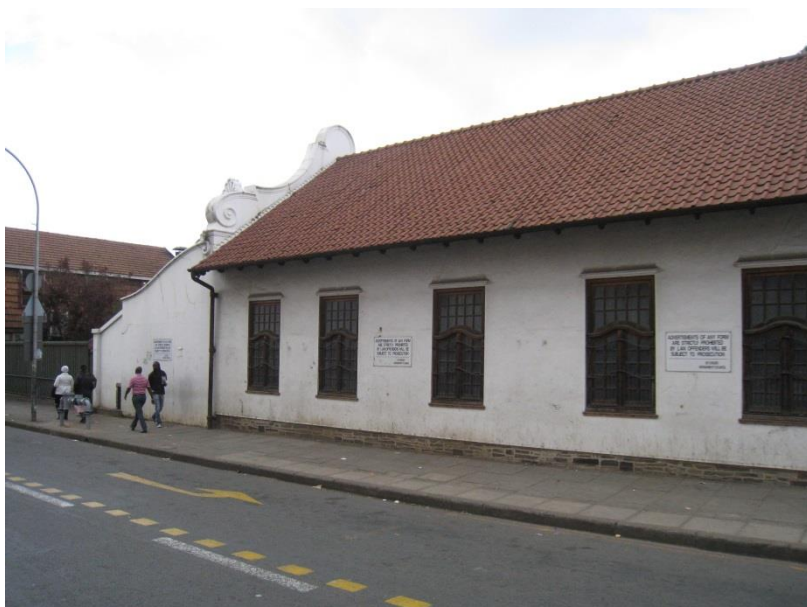
**Fig 129: Church of the Vow from the street showing bill sticking signs**

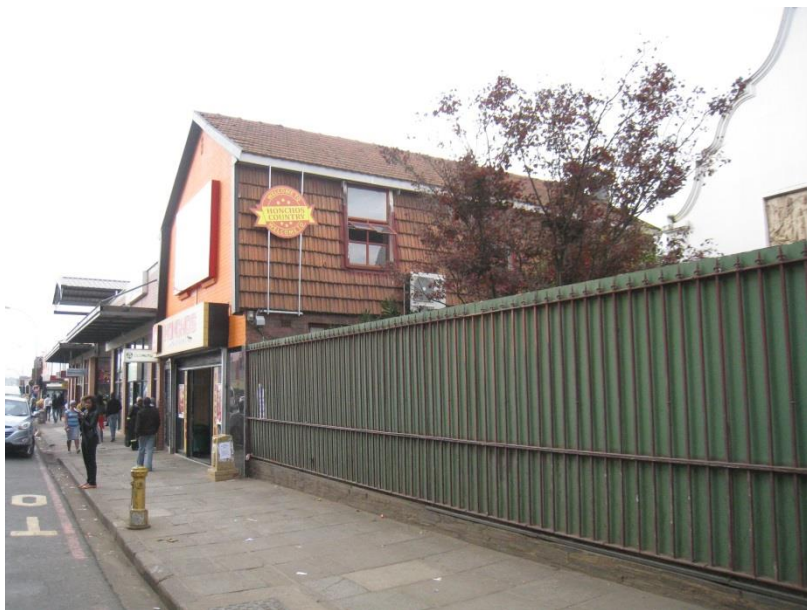
**Fig 132: Looking down Church Street – Voortrekker precinct to the right. Of importance is the shale base to the palisade fence. Note the street – pavement – fence interface**

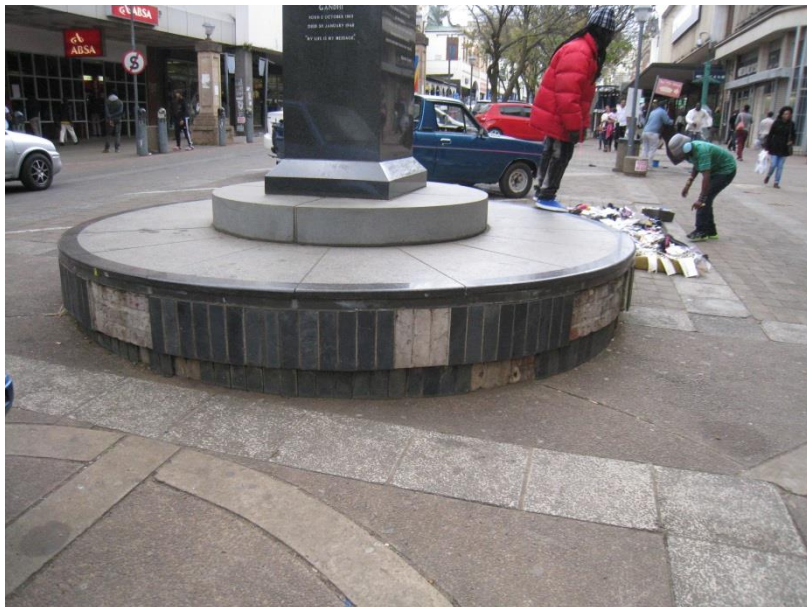
**Fig 135: Base of the statue of Gandhi**

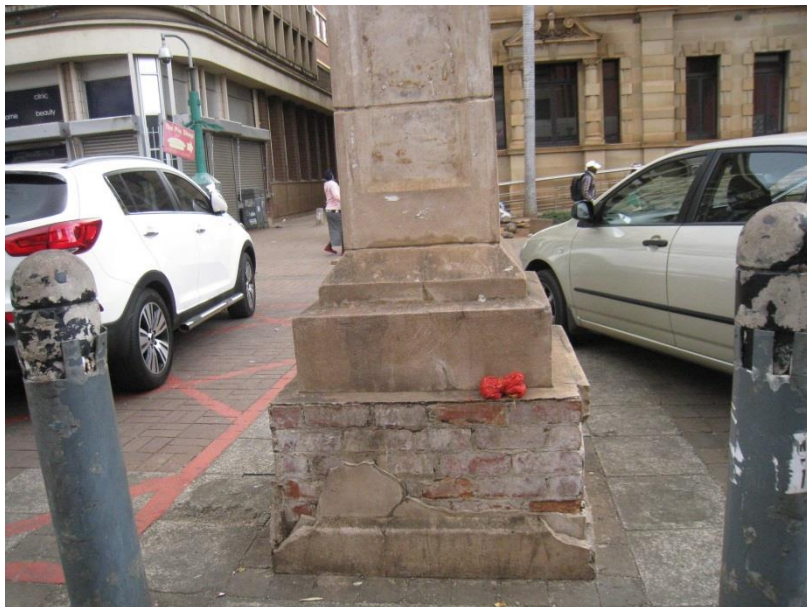
Four Edwardian light bollards mark the square in front of the Colonial Building. They are in varying conditions, from areas of exposed brickwork to suffering the reposting of bill stickers. They are constructed of brick and plastered, with elaborate mouldings at the base, and lights on the top. Whilst Msunduzi Municipality is responsible for the repairs and maintenance to these structures, their continued security in the time of the construction of the IRBT system is vital.

**Fig 137: Bollard showing plaster spalling from base**

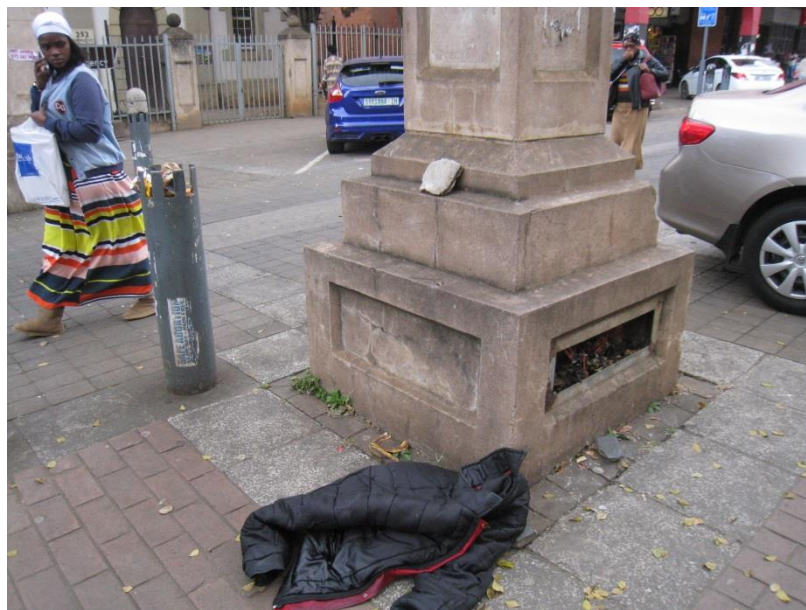
**Fig 139: Close up of bollard**

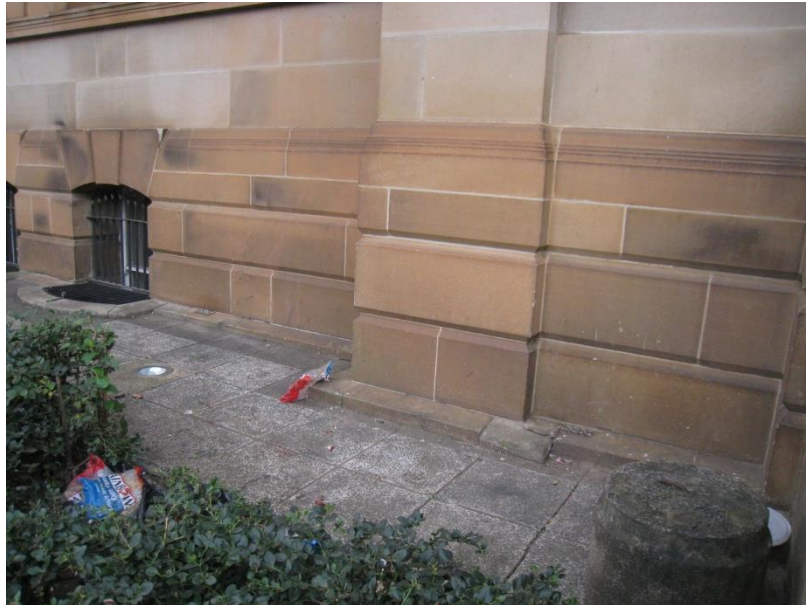
**Fig 143: Refuse outside the Colonial Building. The bag in the planting contains chicken pieces**

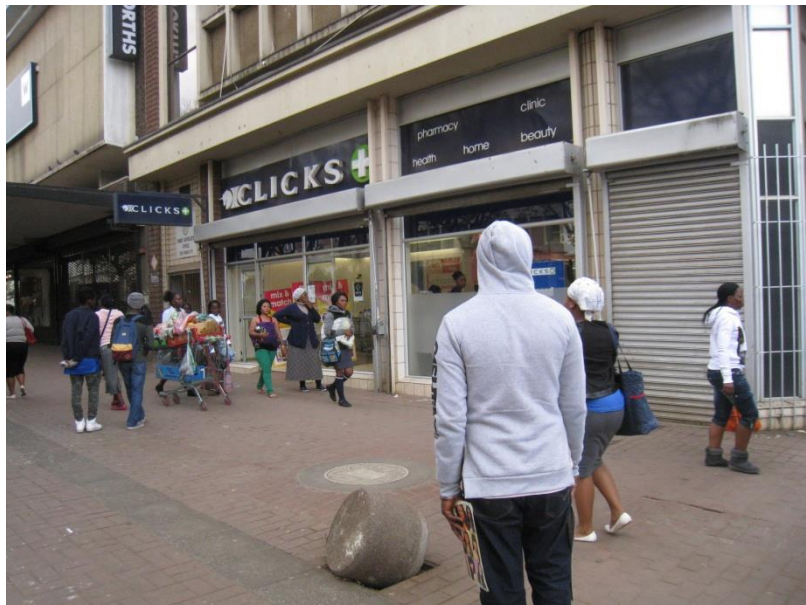
**Fig 144: Overturned bollard**

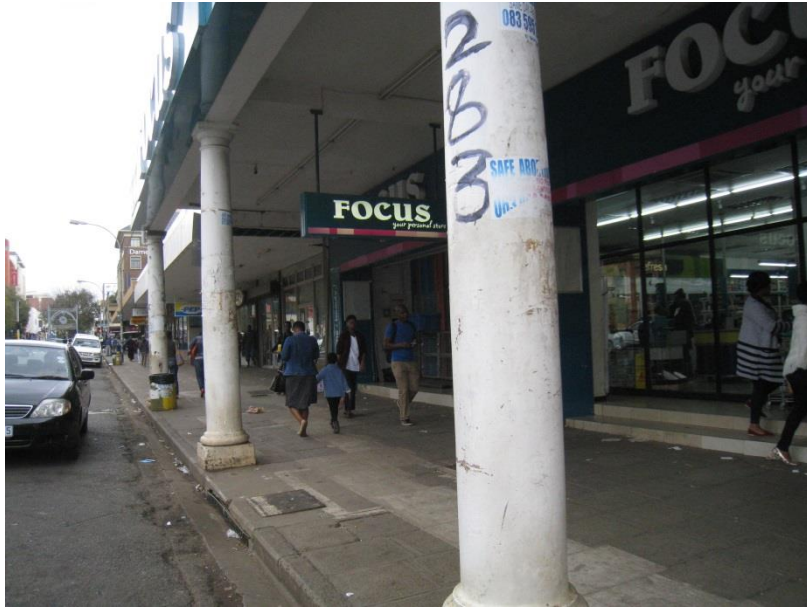
**Fig 145: Evidence of lack of policing of street and private property**
